## Damaged and Partially Collapsed: Pre- and Post-Earthquake Modeling of the Gaziantep Hüseyin Pasha Mosque Minaret and Repair with Internal Steel Reinforcement

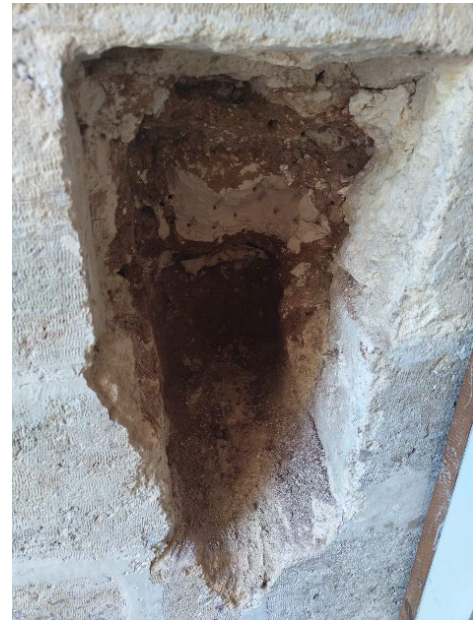
Figure 6. View of the irregular rubble fill inside the pulpit

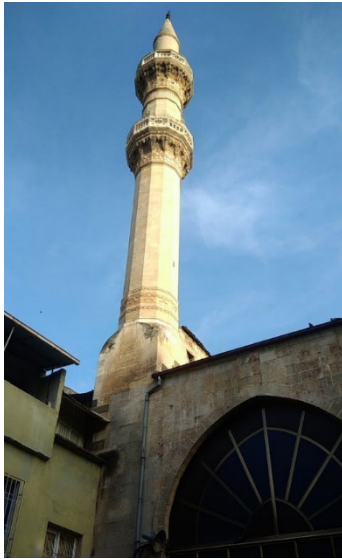
Figure 7. View of the minaret from the front courtyard in 2016 [6]

As seen in Figure 7, the minaret located at the northeast corner of the mosque was constructed leaning against the mosque without any expansion joint. The door openings providing access to the balconies are located directly opposite this leaning area.

The construction of the mosque and minaret separately without any expansion joints is another significant factor influencing the behavior. The minaret leaning against the mosque restricted its displacement towards the mosque, while it could freely displace along its entire height away from the mosque. However, towards the mosque, the displacement was limited to the shaft and balcony region as the base was leaning against the mosque, which led to the collapse at the weakest section, the balcony door region. The collapse of the minaret sections onto the mosque roof supports this observation.

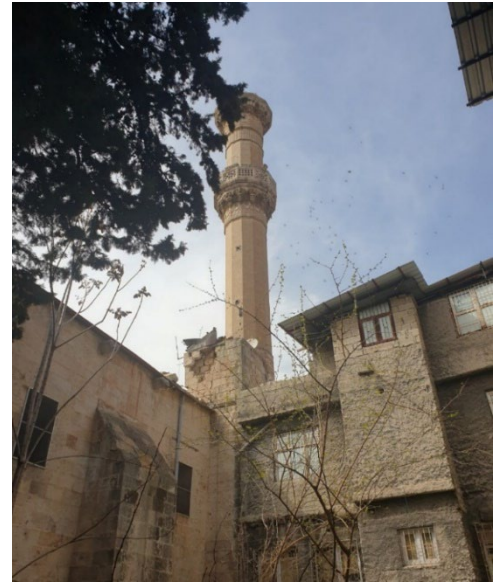
During the earthquakes with epicenters in Pazarcık (Mw 7.7) and Elbistan (Mw 7.6) districts of Kahramanmaraş province on February 6, 2023, the mosque and minaret were also affected. The upper part of the minaret above the second balcony, with a height of 905 cm, collapsed during the earthquake (Figure 8). Additionally, due to the minaret being adjacent to the mosque, crushing in the pedestal and body stones, as well as joint separations, were observed, as seen in Figure 9.

Figure 1. General view of the collapsed minaret from the rear courtyard after the earthquake

In the analytical model prepared for the pre-collapse condition of the minaret, it was found that the cause of the partial collapse in the 9-meter section above the second balcony was displacement rather than stresses in the ashlar masonry.

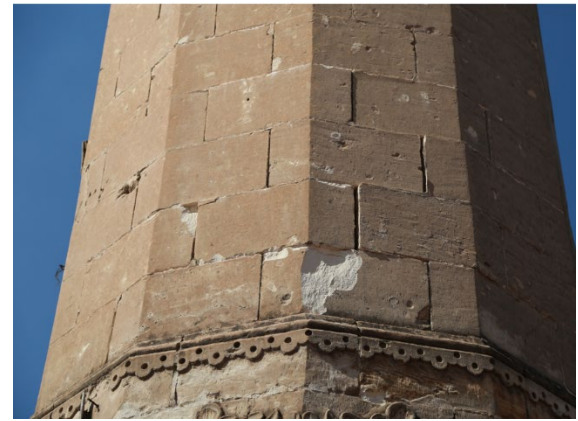
Figure 2. Crushing in the minaret pedestal and body stones, joint separations

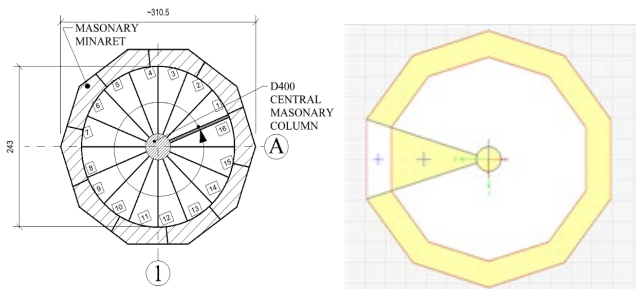
Figure 8. Typical cross-section and model cross-section of the minaret

The minaret's cross-sectional properties (Figure 17) include a cross-sectional area of  $A=28400 \text{ cm}^2$  and a moment of resistance at the weakest section (balcony door) of  $W=1514300 \text{ cm}^3$ . The neutral axis distance  $K$  was calculated as approximately 53.3 cm from the minaret's center.

At the collapse elevation of +30 m, the maximum moment  $M=1241,29$  ton.cm and axial load  $P=20,5$  ton resulted in an eccentricity (e) 60,4cm, which exceeded the neutral axis distance K, confirming that the analytical model aligned with the observed collapse.

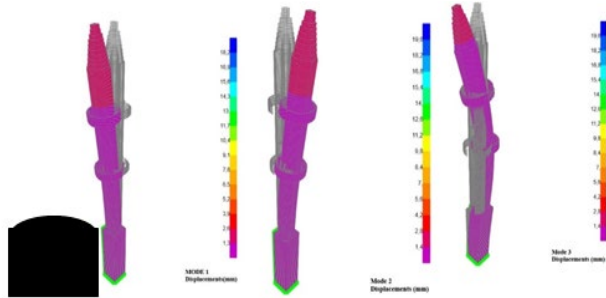
Figure 18. Minaret modes and total displacements

The analytical model developed to examine the minaret's seismic behavior provided displacement results by modes, shown in Table 4 and Figure 18. Axial stresses S33 obtained from the analytical solution were as follows, for G+Ex Envelope Max min -0,783 MPa, max 1,403 MPa, for G+Ex Envelope Min min -2,985 MPa, max 0,164 MPa, for G+Ey Envelope Max min -0,907 MPa, max 0,533 MPa, for G+Ey Envelope Min min -2,52 MPa, max 0,182 MPa.
