International Congress on the Phenomenological Aspects of Civil Engineering

Structural damages of Durrës (Albania) Earthquake

Hüseyin Bilgin^{*,1}, Marsed Leti².

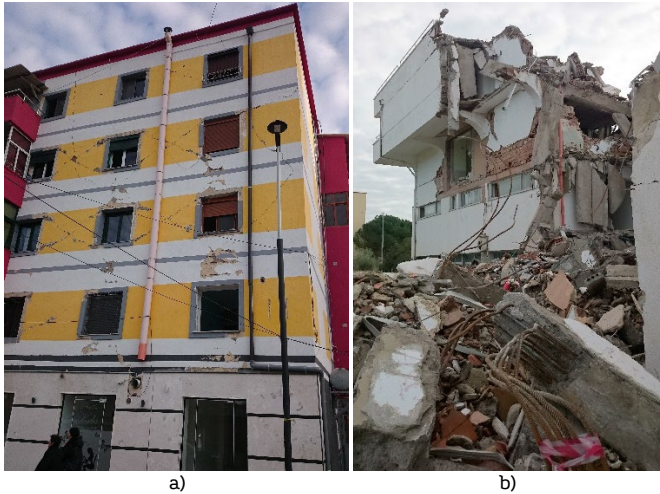
According to recent reports, 80000-100000 buildings were seriously damaged or collapsed [3]. It was observed that URM or RC moment resisting frames with hollow clay tile infill partitions are the most popular structural systems in the region. The main structural materials are unreinforced masonry composed of rubble, stone, brick, and hollow clay tile. Moreover, observations revealed that most of the damages in Durrës were restricted to old masonry and non-ductile RC buildings (Fig 3).

Figure 3: Two types of typical damages from Vore and Durrës; a) Severely damaged URM building; b) Partially collapsed non-ductile RC building

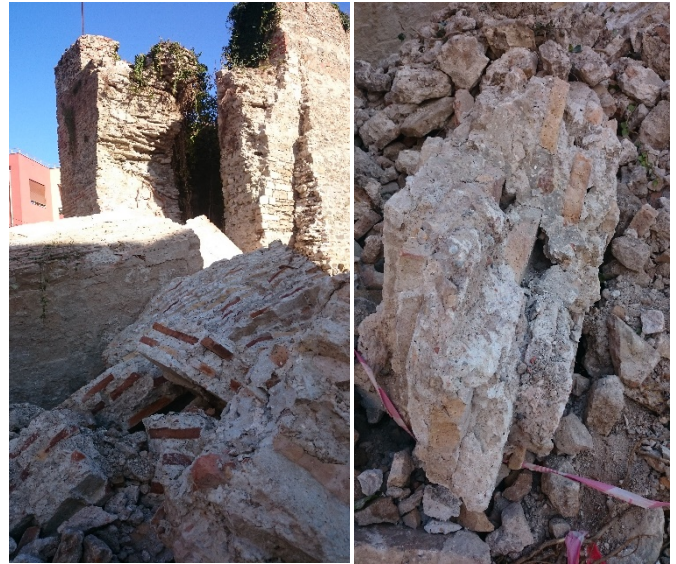
Figure 8: Presence of multi-leaf clay brick walls and collapse of the external leaf: detail of collapse in Durrës, Castle of Durrës (left) and partial collapse remains (right)

Unconnected outer and inner wythes are given in Figure 8. These types of deficiencies led to out-of-plane failures as shown above.

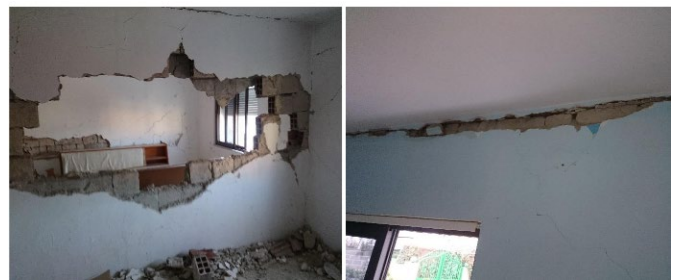
Figure 9: Out-of-plane failure of URM walls

In many cases, at corner points of the buildings, masonry units were not properly overlapped to ensure an earthquake-resistant connection. This causes walls to be separated at initial stages of the quake. After that, out-of-plane failures were initiated due to poor restraining conditions. These types of damages are shown in Figure 9.

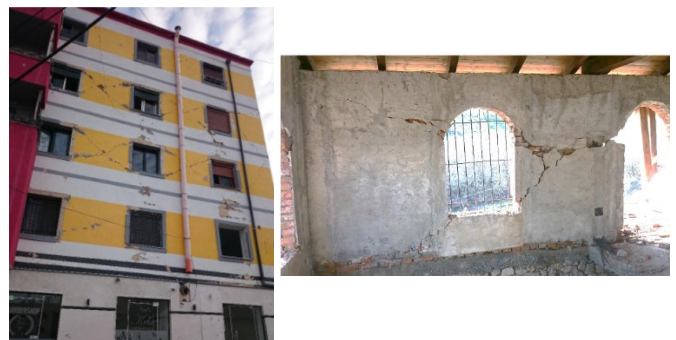
In-plane, failure mechanisms are commonly observed near the openings as shown in Figure 10.

Figure 10: Typical diagonal shear cracks of piers on a multistory masonry building

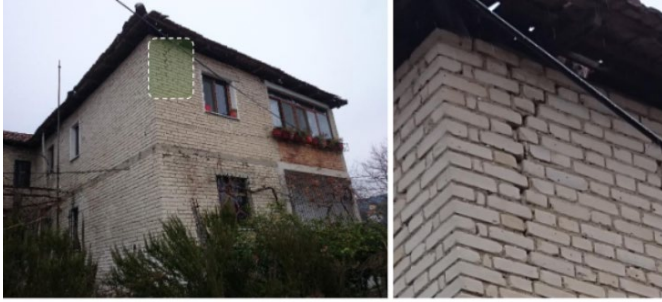
Poor connection between walls - walls and roof, the lack of bond beams leads usually to the failure of corners of masonry buildings. Some

patterns of this failure are shown from the images below during the observations done after November 26 earthquake (Fig. 11).

Figure 11: Anchorage-related corner failure of a masonry building

Restraining effect of crossing walls was reduced by wall openings placed too close to the building corner. Window and door openings weaken the connection of crossing walls. The failure mode involving separation of the front facade and return walls was commonly seen due to poor interconnection of return walls, as can be observed in the multiple examples shown in Figure 11.

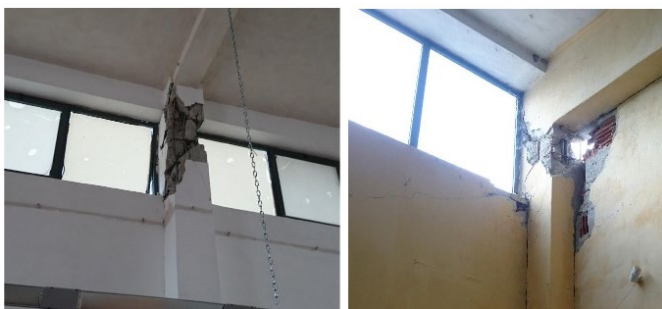
Figure 12: Typical shear failure of short columns in RC buildings

Short column mechanism developed as a reason of continuous openings located at the top or bottom of infill walls between columns as shown in Figure 12.

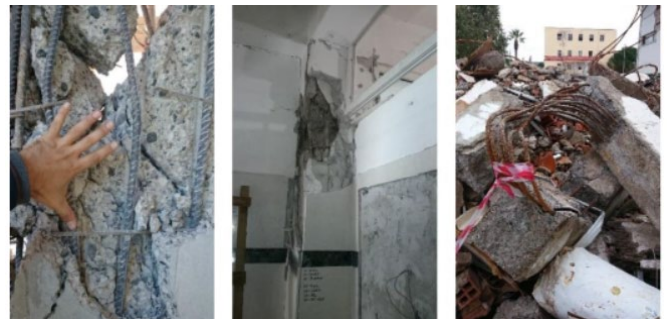
Figure 13: Inadequate detailing caused buckling of longitudinal reinforcement in plastic hinge regions (spacing of transverse reinforcement)

Based on most of the observations during the November 26, 2019 earthquake, a number of detailing flaws were observed in damaged buildings (Fig 13.).

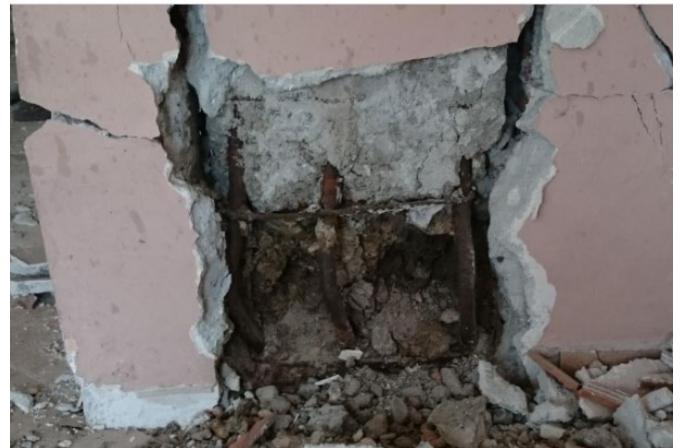
Concrete quality plays a significant role on the structural performance against earthquakes. In Albania there are many cases where hand-made concrete is used, especially in the old buildings. Moreover, workmanship service was not at the desired level resulting thus in a very low material quality. All these factors including corroded rebars together with the poor-quality material of the building led to poor performance during this earthquake (Fig 14.).

Figure 14: Column failure due to the corroded rebars and poor concrete quality

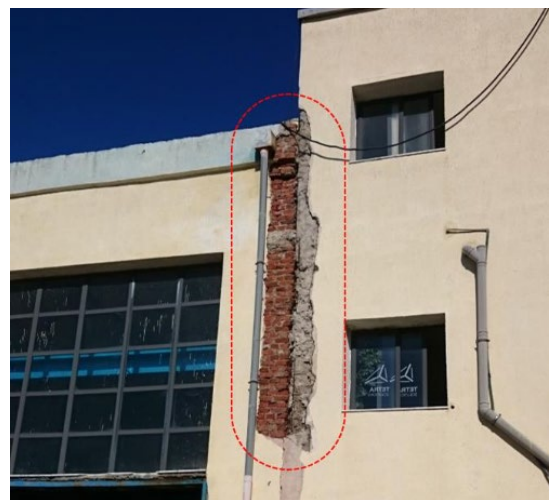
Figure 15: Pounding failure due to lack of enough space b/w adjacent buildings

Another damage pattern was observed in many nearby buildings due to hammering effect. The building seen in Figure 15 can be considered as one of the typical examples of the hammering effect damage seen during the investigations.

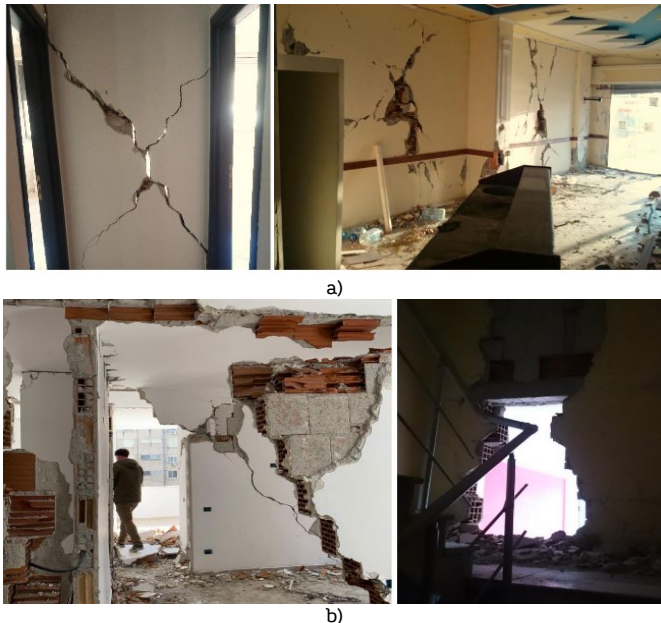
In-plane and out-of-plane failure of masonry infill wall are widely observed in the RC buildings damaged during November 26 earthquake. Especially for low and mid-rise buildings it is likely that the infill walls of the ground story in the RC frames will fail earlier. This happens as the fact that infill walls found in the ground story, obtain higher in-plane demands during an earthquake. As the in-plane demand reduces at the upper floor, the out-plane forces increase due to acceleration increases. Figures 16 show the in-plane and out-plane damage patterns of the investigated RC buildings.

Figure 16: Heavily damaged partition walls; a) In-plane failure, b) Out of plane failure
