# Comparison of Classical and Voxel Model Analyses of the Gaziantep Hüseyin Paşa Mosque Observed During the February 2023 Earthquake

Yusuf Demirel<sup>1</sup>, Erdinç İbas<sup>2</sup>

<sup>1</sup>Gazi University, Faculty of Engineering, Civil Engineering

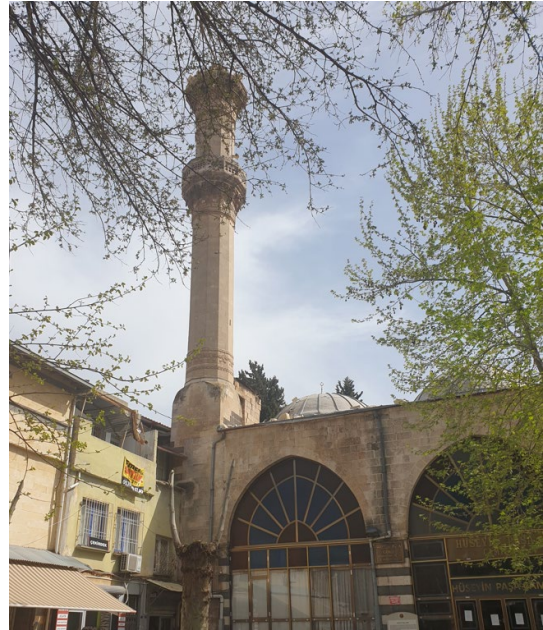
Figure 2. Minaret damage

In recent years, earthquakes of magnitude Mw 5.5, 5.8 and 4.6 occurred in June, July and August of 1971 and caused serious damage. Earthquakes of magnitude Mw 4.4 occurred in 1978 and Mw 5.0 occurred in 1986 and caused some damage [1]. Gaziantep province also suffered damage from the earthquakes centered in Pazarcık (Mw 7.7) and Elbistan (Mw 7.6) in February 2023. After the earthquake, the 9.80 m. section of the mosque minaret above the 2nd balcony collapsed on the dome (Figure-2). The dome closest to the minaret has been damaged by impact (Figure-3). When the general condition of the mosque was examined with observation and point cloud, it was observed that cracks occurred in the carrier arches of some domes and on the edges of the dome (Figure-4). It was also determined that the

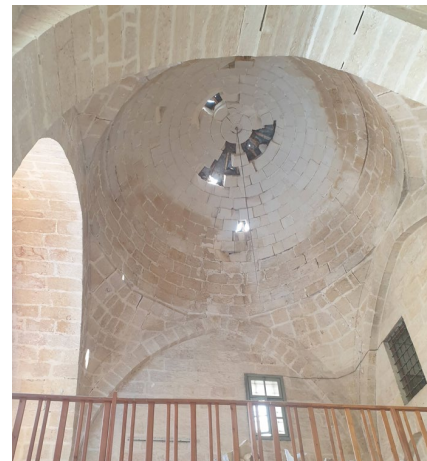
Figure 3. Dome damage

dome stones moved from their places due to the depletion of the adhesion of the connection mortars.

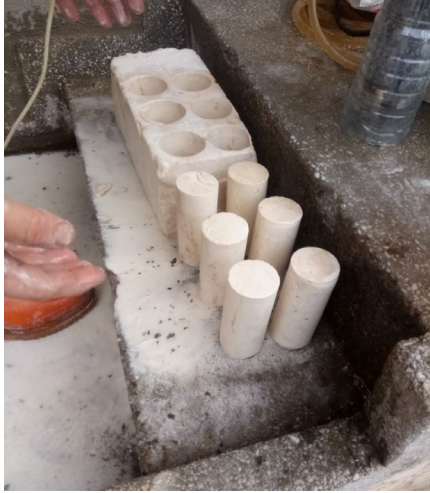
Figure 5. Core samples

stone walls, core samples were taken from the load-bearing walls for use in modeling. Free compression and splitting tensile tests were performed on these samples, 6 core samples with a diameter of 53 mm were obtained for the tests, 8 core samples with a height of 53 mm and 3 core samples with a diameter of 26 mm were obtained, (Figure-5).

The values obtained from the core samples taken are given in Table 1 and Table 2. According to the data obtained from the experiments, the average compressive strength of the wall sample was found to be 8.62 MPa (Table-1), the average tensile strength was found to be 2.39 MPa (Table-2) and were used in the analysis models. The specific gravity of the keymum stone used in modeling was taken as 2.7 tons/m<sup>3</sup>.

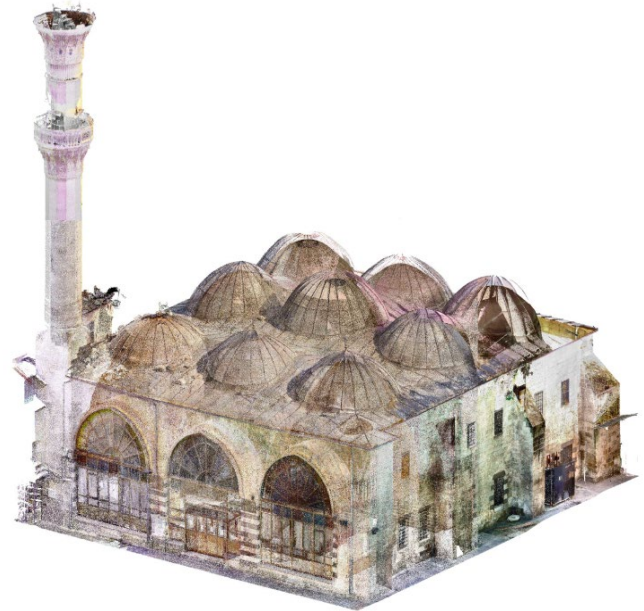
Figure 6. Survey obtained from the Hüseyin Pasha Mosque point cloud

In order to determine the geometrical condition of the structure before and after the earthquake, data was collected for survey purposes using the point cloud method (Figure-6). Point cloud readings were obtained by laser scanners in field measurements and consist of approximately 24 million points before the earthquake and 36 million points after the earthquake with three-dimensional coordinates. These measurements were carried out with distance measuring devices called TLS (Terrestrial Laser Scanner). Point cloud readings provide high accuracy in obtaining the current condition of the structure and enable modeling and detailed damage status.

Voxel model technique/method was used to create the building model from point cloud data. Voxel is the three-dimensional equivalent of a pixel. While pixel defines a point in two dimensions, voxel expresses the graphic information that defines a point in three-dimensional space. Voxel modeling is based on the principle of slicing the obtained point cloud cluster at certain intervals and superimposing the plan or section planes obtained from these slices. This method allows the building model to be represented in three dimensions in detail. Figure 6 shows the relief of Hüseyin Paşa Mosque obtained from the point cloud and Figure 14 shows the voxel model view of this point cloud.
