Pressurize Cavity Between Building Structures at The Facility of Sewage System in Kyiv

Abstract

The article examines the possibility of sealing cavities between buildings structures of the sewage network using polymer material SPT® Resins. The need to pressurize junctions, in particular at sewer network facilities, is a widespread problem that requires a quality solution. The authors conducted a laboratory experiment, based on the results of which sealing of connections was performed on a real object with a further inspection of the state of the sealed connection. Based on the results of the work, conclusions made about the effectiveness of the technology of sealing cavities between building structures using polymer material SPT® Resins.

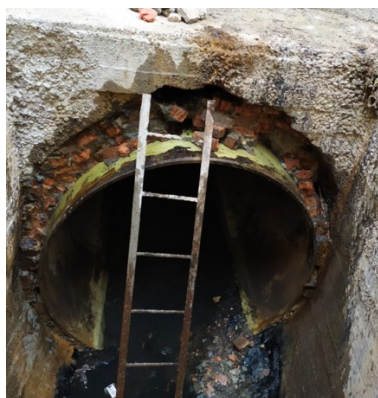
During reconstruction chambers, KK7, KK8, KK1a of jumper between Livoberezhnyi collector and sewerage station «Poznyaki» on Kollektorna 1 in Darnitsky district of Kyiv, cavities were found at the junctions of fiberglass pipes to an outer reinforced concrete structure of the chambers (fiberglass pipe was mounted in a reinforced concrete pipe during last reconstruction of sewage system) (Figure 1). There was an intense water leak through the detected cavity into a construction.

Figure 1. Junction of fiberglass pipes to the outer reinforced concrete structures of the chamber

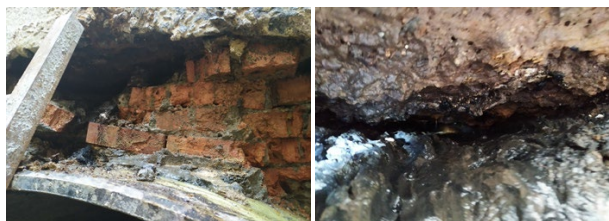
Figure 2. Photo of cavities in the upper part of the manifold above the fiberglass pipe

Visual inspection was carried out by video recording of cavities in the upper part above the fiberglass pipe with a remote mini-camera. Throughfall holes were detected in the outer reinforced concrete pipe at a distance of 1,5-2 m from the ends behind which placed cavities that filled with water.

Summarizing results of the structures inspection was determined that water accumulates in the cavities behind reinforced concrete pipe and then due to holes in the pipe goes to the gap between fiberglass pipe and outer reinforced concrete pipe, then flow outside through holes in brickwork.

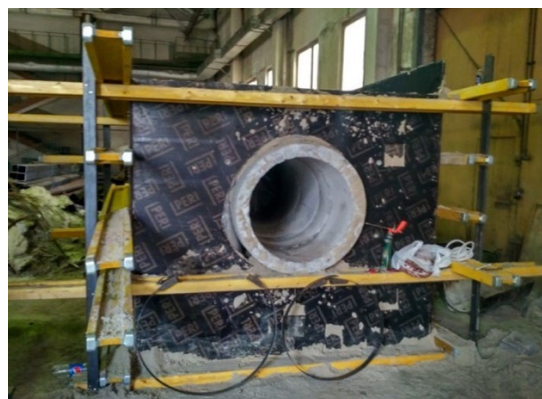
The special stand was designed and created for conducting experimental research. It was assembled from beams and decking of formwork. The bore 1000 mm in diameter was cut at one of the webs of the stand. Through this bore the concrete pipe was mounted. The general view of the stand is displayed in Figure 4.

The concrete pipe consisted of 5 segments that mounted one after another, one segment went outside through the bore. Between each segment was a gap 20 mm wide (for joint imitation). The pipe was wrapped with film and covered by sand. A layer of sand was 300 mm.

Figure 4. General view of experimental stand

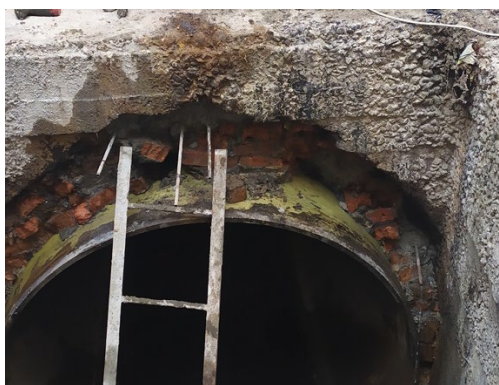
Figure 9. Mounting injection pipes and restoring damaged areas

The next processes include; drilling holes, installing injection pipes to a project depth (Figure 5); mounting plastics injectors into injection pipes; restoration of damaged zones of masonry and plastering areas where water may flow out and polyurethane material may go outside of the structure; preparing operation station.

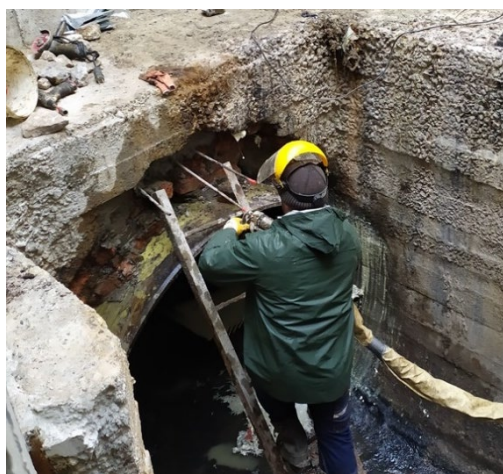
Material injection started with connection of the injectors to an injection gun which polyurethane material SPT® and compressed air are fed through rubber pipes. After pushing the gun trigger polyurethane material is mixed with air and comes through the injector and injection pipe to cavities and filled them.

Figure 10. Injection process of polyurethane material SPT®

Junction pressurizing was carried out by filling cavities with polyurethane material SPT®. Before injection polyurethane material SPT® was heated approximately to +50°C.

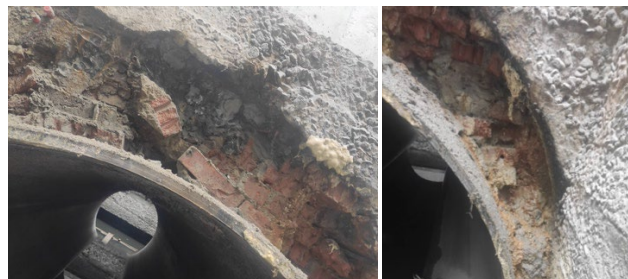
5) Humid state monitoring of junction. After 30 min when the material had completely polymerized was carried out photographing and video recording of the surface state of the pressurized junction. There was no water leakage.

The second inspection was carried out in 10 days after the previous one. There also was no water leakage (Figure 11).

Figure 11. State of junction in 10 days after pressurizing
