PACE-2021

Vertical Ground Motion Effects on the Seismic Responses of Historical Masonry Structures

2.1. Kaya Çelebi Mosque

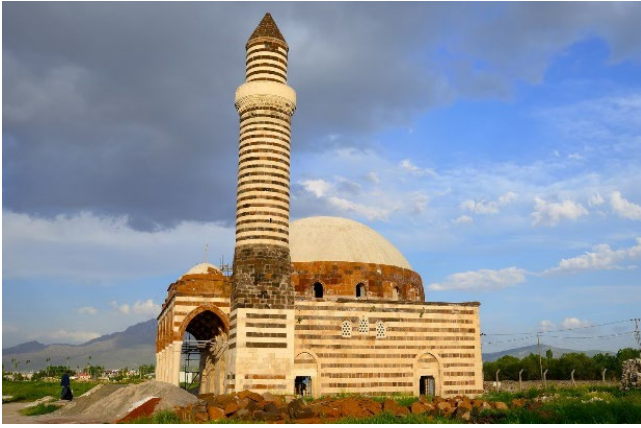
Figure 1. Kaya Çelebi Mosque [19]

Kaya Çelebi Mosque is located in the Ortakapı district of Van province, Turkey. Its construction was started by Kaya Çelebizade Koçi Bey in 1660 and it was completed by Cem Dedeoğlu Mehmet Bey in 1663 [18]. The mosque, which consists of two parts as prayer place and porch, has a square plan with 16.20×16.20m. The prayer place is covered by a main dome with a radius of 7.5m. It also has walls with a thickness of 1.8m, and eight arches supporting the main dome. The porch consists of small domes, columns, arches, and stretchers. In the Van Earthquake on 23 October 2011, the cone part of the minaret was collapsed. In the second earthquake on 09 November 2011, devastating damages occurred in the main dome covering the prayer place and in the porch section of the mosque. It was also observed in conditions such as material deformations and environmental deterioration that could affect the structural integrity. A photograph of the restored mosque is given in Fig. 1. Fig. 2 presents a photograph of damages and deteriorations in the mosque due to the 2011 Van Earthquakes.

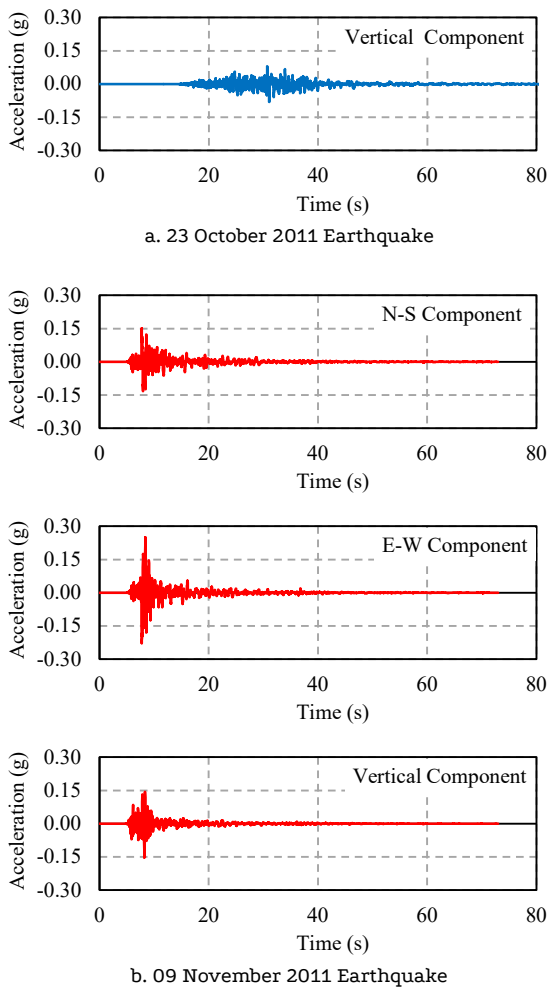
Figure 4. The acceleration time-history graphs of Van Earthquakes

The dynamic analyses of the mosque are performed using horizontal and vertical components of the 2011 Van Earthquakes. The acceleration time-history graphs of Van Earthquakes are plotted in Fig. 4. In the analyses, the damping ratio is considered as %5. In order to accurately predict the dynamic behavior of the mosque, the first 150 modes are also considered.

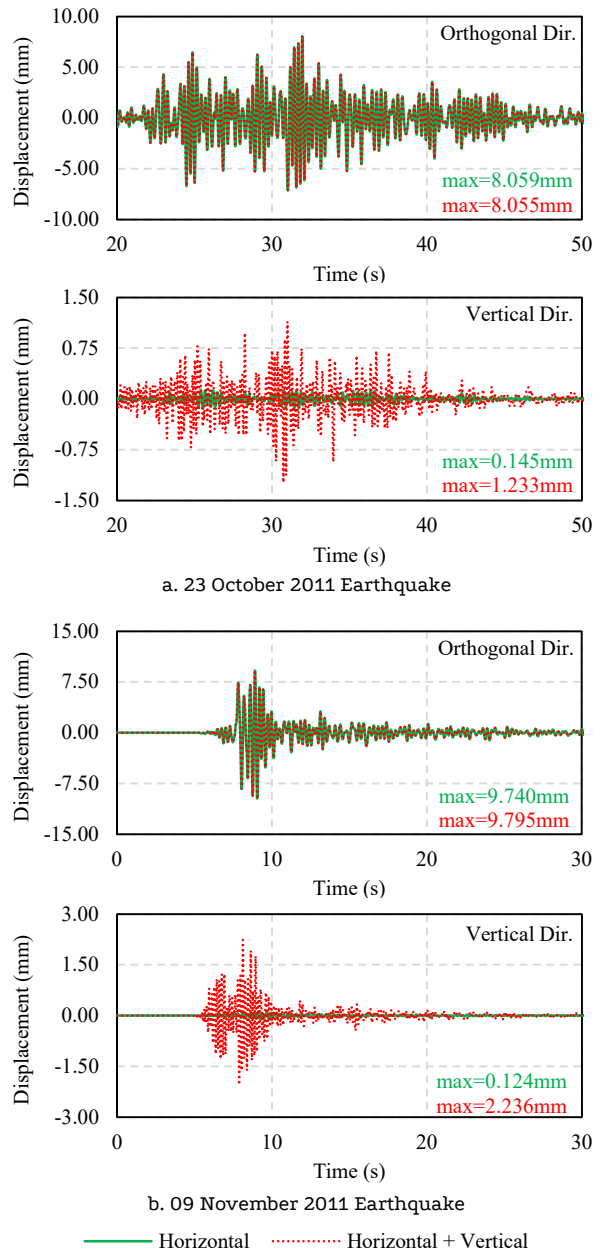
Figure 5. The time-history of dome displacements for orthogonal and vertical directions of mosque

As a result of the linear time-history analyses of the mosque, time-histories of displacements at the dome center and displacement contour diagrams are presented in Figs. 5-7. The displacements in the orthogonal direction which are estimated using only horizontal component and combined horizontal and vertical components are 8.059mm and 8.055mm for the first earthquake and 9.740mm and 9.795mm for the second earthquake, respectively. In the vertical direction, these displacements obtained with and without vertical components of earthquakes are determined as 0.145mm and 1.233mm for the first earthquake and 0.124mm and 2.236mm for the second earthquake, respectively (Fig. 5).

As can be clearly seen in Fig. 5-7, the displacements in the vertical directions of the inspected mosque are significantly influenced although these values in orthogonal direction are constrictedly affected by vertical ground motions.

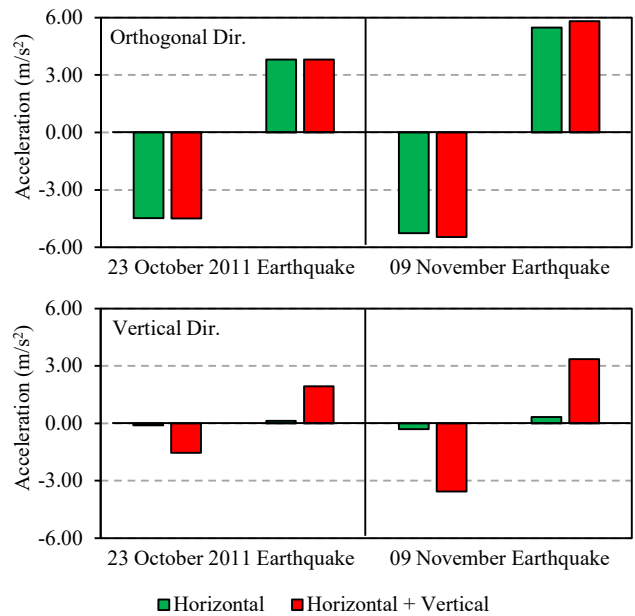
Figure 8. The maximum absolute accelerations obtained from main dome for orthogonal and vertical directions

The absolute acceleration is a significant parameter in terms of earthquake forces applied to structural and non-structural elements. These accelerations at the main dome center, where the highest structural responses are generally obtained, are examined. The maximum absolute accelerations are given in Fig. 8. The maximum accelerations in the orthogonal direction which are determined using only horizontal component and combined horizontal and vertical components are 4.473m/s² and 4.491m/s² for the first earthquake and 5.489m/s² and 5.810m/s² for the second earthquake. In the vertical

direction, these accelerations obtained with and without vertical components of earthquakes are determined as 0.126m/s² and 1.933m/s² for the first earthquake and 0.333m/s² and 3.563m/s² for the second earthquake, respectively (Fig. 8). It can be observed that vertical ground motions increase the absolute accelerations of the main dome.

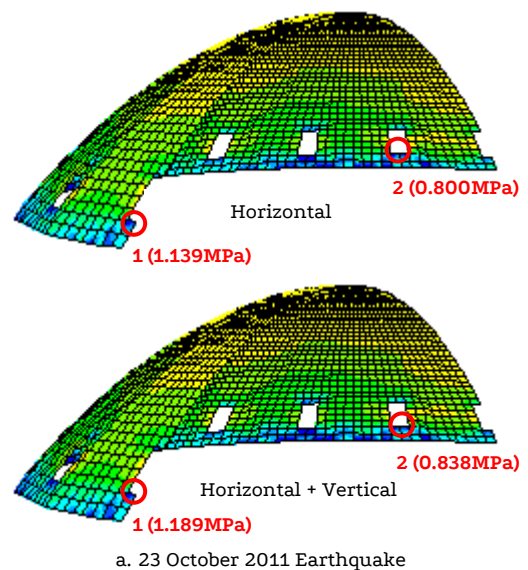
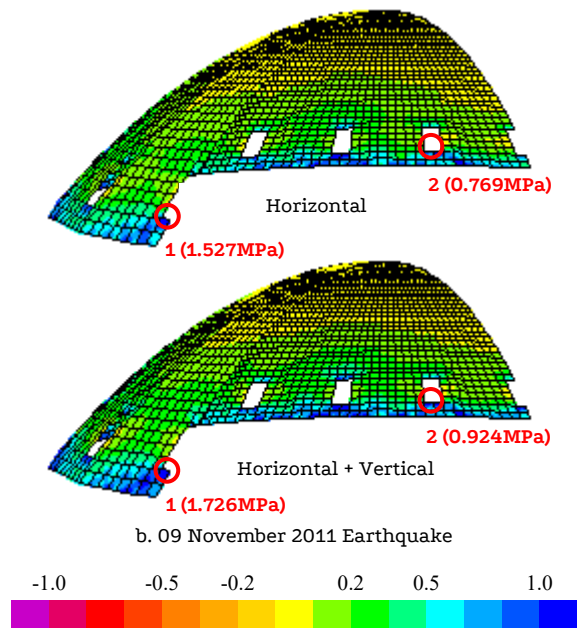
Figure 9. The tensile stresses of the main dome (units in MPa)

The tensile stress diagrams of the main dome collapsed during the 2011 Van Earthquakes are plotted in Fig. 9. Measuring points are chosen to compare the tensile stresses in the dome. The tensile stresses of the measuring points which are estimated using only horizontal components are 1.139MPa and 0.800MPa for the first earthquake and 1.527MPa and 0.796MPa for the second earthquake. These values calculated using three earthquake components are determined as 1.189MPa and 0.838MPa for the first earthquake and 1.726MPa and 0.924MPa for the second earthquake.
