## International Congress on the Phenomenological Aspects of Civil Engineering

Research Article

### Operational Modal Analysis of a Historical Wooden Building

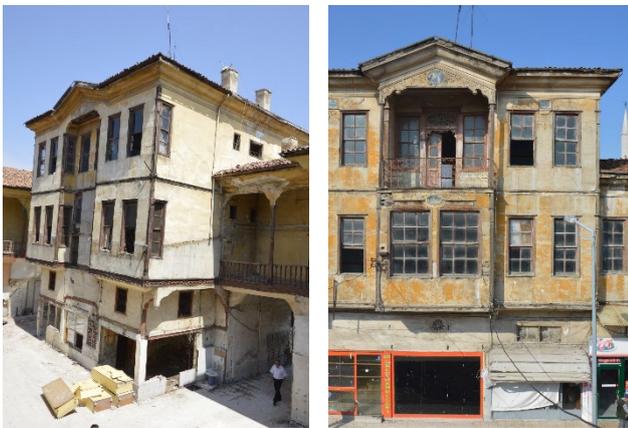
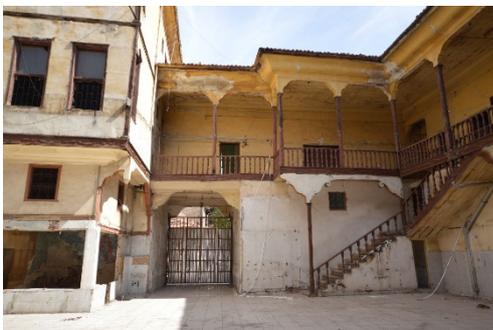
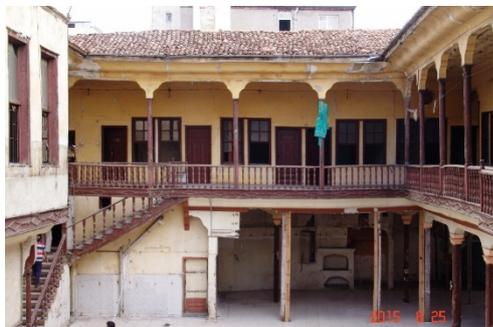
Figure 2. Views of the building before restoration

The building was constructed with "hımsı" system which is traditional system used in historical building widely in Anatolia. Timber frame system with infilled adobe (stone, brick) is the basis of the hımsı

system. Also, the building walls were nailed with timber laths and were plastered with mortar. This application is called as “Bağdadi” in the Anatolian region. Some views of the building belong to before restoration are shown in Fig. 2.
