## Damaged and Partially Collapsed: Pre- and Post-Earthquake Modeling of the Gaziantep Hüseyin Pasha Mosque Minaret and Repair with Internal Steel Reinforcement

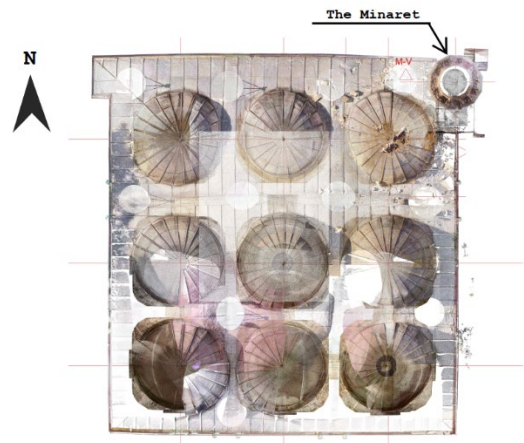
The minaret, originally constructed with a single balcony, has undergone significant changes over time. During the occupation period, the minaret was demolished up to the pulpit level by the French, and later, it was reconstructed with two balconies at a greater height without any intervention in its foundation and base. During the reconstruction process, the interior of the pulpit was filled with irregular fill material. The fill inside the borehole drilled in the pulpit area to identify the quality of this irregular fill is shown in Figure 5. Observations made in the inspection hole revealed that the rubble from the 1920 demolition was used as irregular fill. According to the mosque's plan, the minaret, located at the northeast corner of the mosque, was built leaning against the mosque without any expansion joint (Figures 5 and 7). The door openings providing access to the balconies are located in the northeast direction, opposite this leaning area.

Figure 5. Plan view of the mosque and minaret

As seen in Figure 7, the minaret located at the northeast corner of the mosque was constructed leaning against the mosque without any expansion joint. The door openings providing access to the balconies are located directly opposite this leaning area.

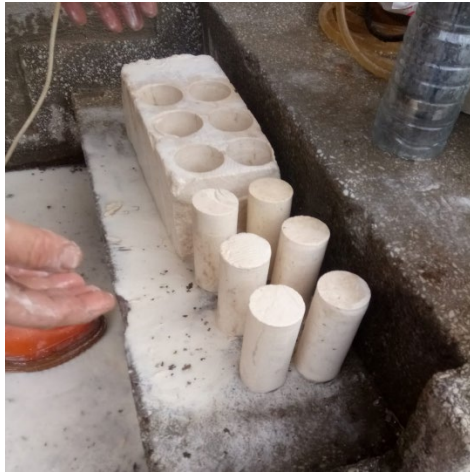
Before the February 6, 2023 earthquake, stone block samples were taken from the minaret's body walls to determine the compressive strength of the cut stones used in the structure. From these stones, 6 core samples with a diameter of 53 mm, 8 core samples with a height of 53 mm, and 3 core samples with a diameter of 26 mm were obtained, as shown in Figure 10. Uniaxial compressive strength and splitting tensile strength tests were performed on these samples.

Figure 10. Samples obtained from the minaret body wall stone

The values obtained from the core samples are provided in Table 1 and Table 2. According to the test results, the average uniaxial compressive strength of the wall samples was found to be 8.62 MPa, and the average splitting tensile strength was 2.39 MPa.

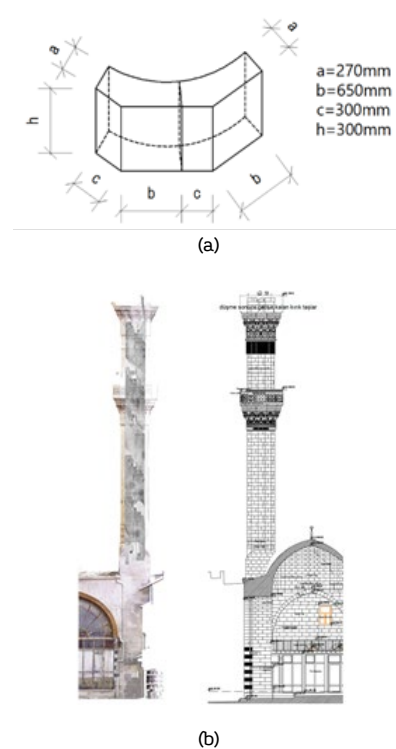
The uniform shape and size of the stones used in the minaret body also facilitated the modeling process. The dimensions of these stones are provided in Figure 11, and this stone size was used in the voxel model.

Figure 3. (a) Typical cross-section of the minaret cut stone (b) Current minaret point cloud readings and survey obtained from the point cloud

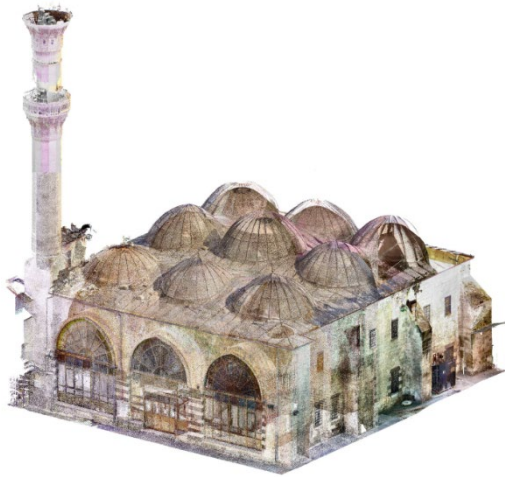
The external view of the point cloud model of the mosque and minaret obtained after the earthquake is provided in Figure 12.

Figure 4. External view of the mosque and minaret point cloud model after the earthquake and Pazarcık earthquake east direction

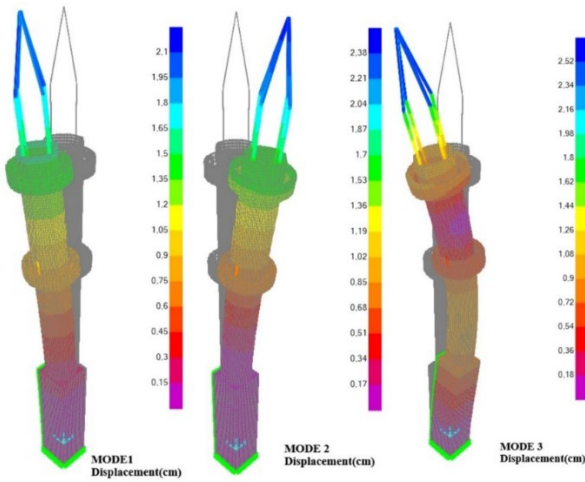
The analytical model results after the repair and reconstruction of the upper part above the collapsed second balcony are presented in Table 5 and Figure 22. After the reinforcements, reductions in the minaret's period and displacements were observed. At the collapse level of +30 m, the moment value read from the analytical model was  $M=297.7$  ton.cm and the axial load was  $P=5.65$  tons, resulting in an eccentricity (e) of 52.7 cm. In this case, the eccentricity (e) was found to be smaller than the core distance (k), indicating that the tensile zone in the cross-section of the structure was reduced.

Figure 22. Minaret modes and total displacements

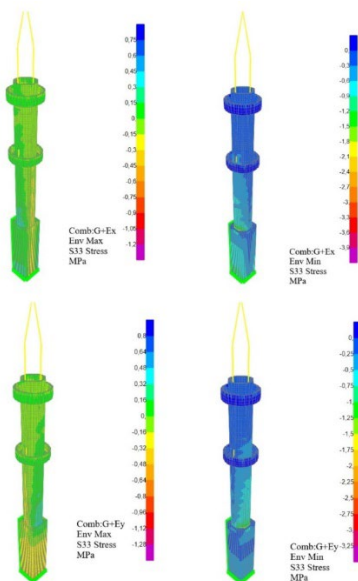
The axial stresses S33 obtained from the analytical model after the repair and reconstruction of the upper balcony are shown in Figure 23. The values are as follows: G+Ex Envelope Max: min -1.275 MPa, max 0.831 MPa; G+Ex Envelope Min: min -4.01 MPa, max 0.205 MPa; G+Ey Envelope Max: min -1.367 MPa, max 0.901 MPa; G+Ey Envelope Min: min -3.467 MPa, max 0.22 MPa.

Figure 23. S33 stresses of the minaret after strengthening, MPa

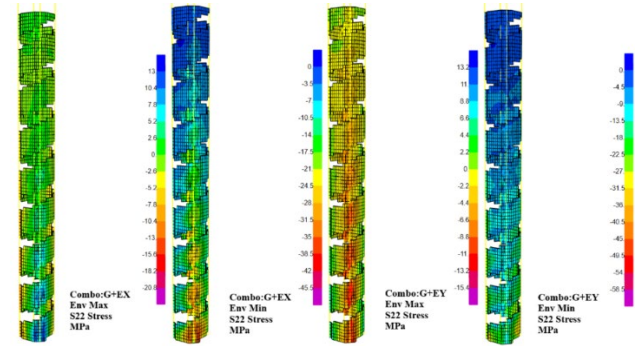
The axial stresses S22 obtained from the analytical model for the steel plate, which will be spirally wrapped around the steel columns along the minaret, are shown in Figure 25. The values are: G+Ex Envelope Max: min -22.7 MPa, max 13.8 MPa; G+Ex Envelope Min: min -47.4 MPa, max 2.2 MPa; G+Ey Envelope Max: min -16.9 MPa, max 12.1 MPa; G+Ey Envelope Min: min -59.1 MPa, max 0.5 MPa. The stress results are shown in Figures 24.

Figure 24. S22 stresses of the steel plate after repair, MPa
